**CONTAMINANT DELINEATION INVESTIGATION**

**4125-4149 LACONIA AVENUE  
BRONX, NEW YORK 10466**

**MECC PROJECT NO. M16917A**

**MERRITT ENVIRONMENTAL CONSULTING CORP.**

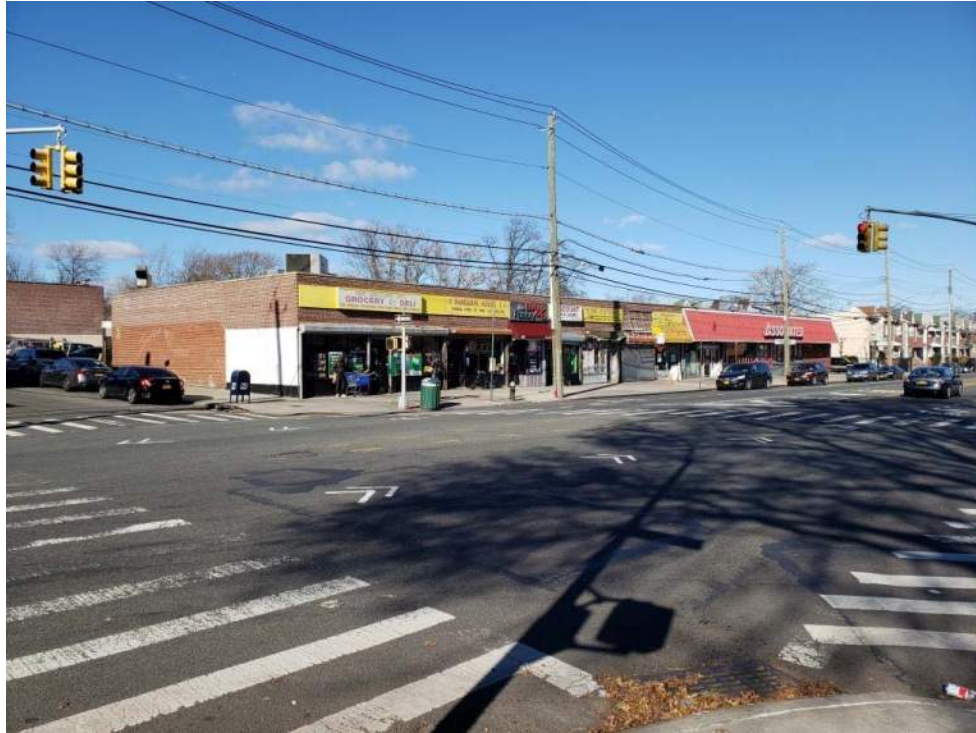
**Photograph 1:** View of the Site building looking north-northwest from across the intersection of Laconia Avenue and East 230<sup>th</sup> Street. The former dry cleaner space is marked by the lack of overhead signage.

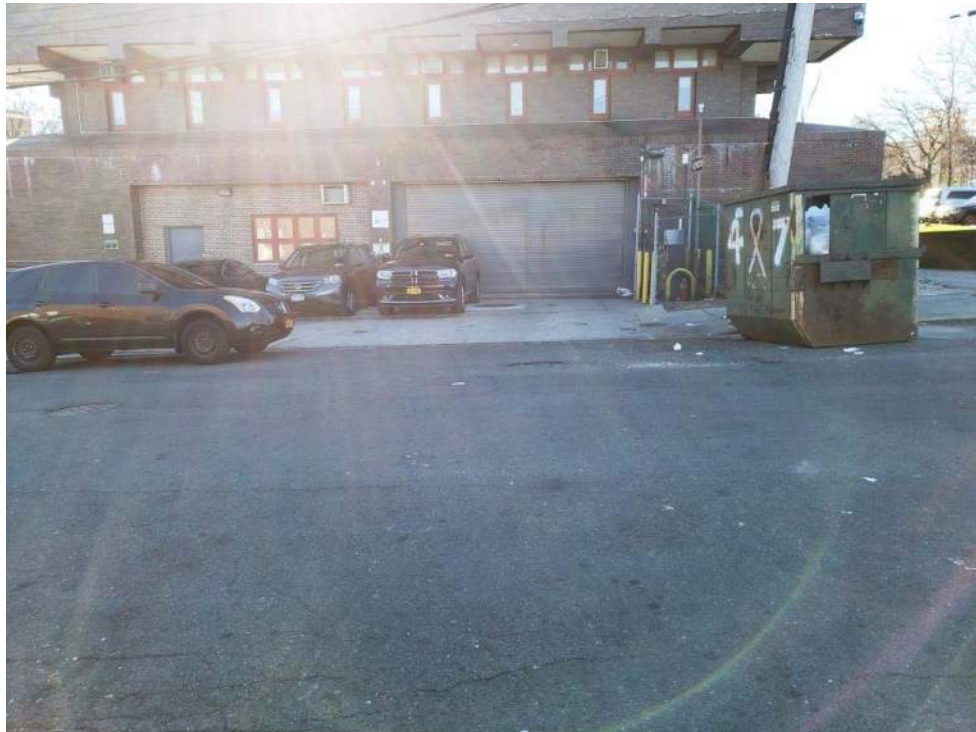
**Photograph 2:** Gasoline UST area at the south-adjointing police station looking south from the Site and across East 230<sup>th</sup> Street.

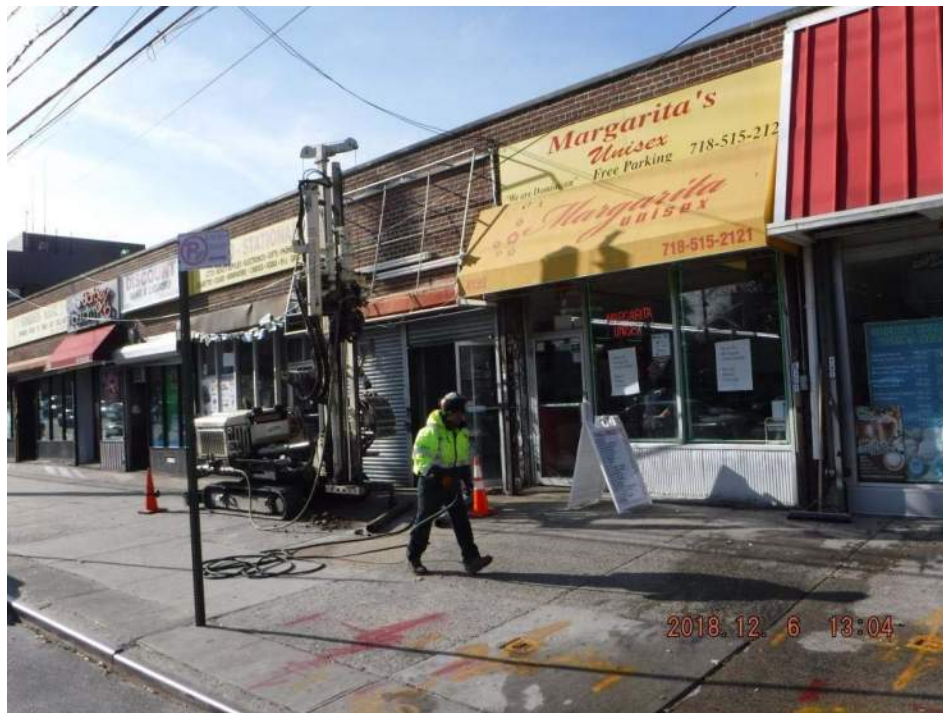
**Photograph 3:** Installation of MW3 looking southwest.

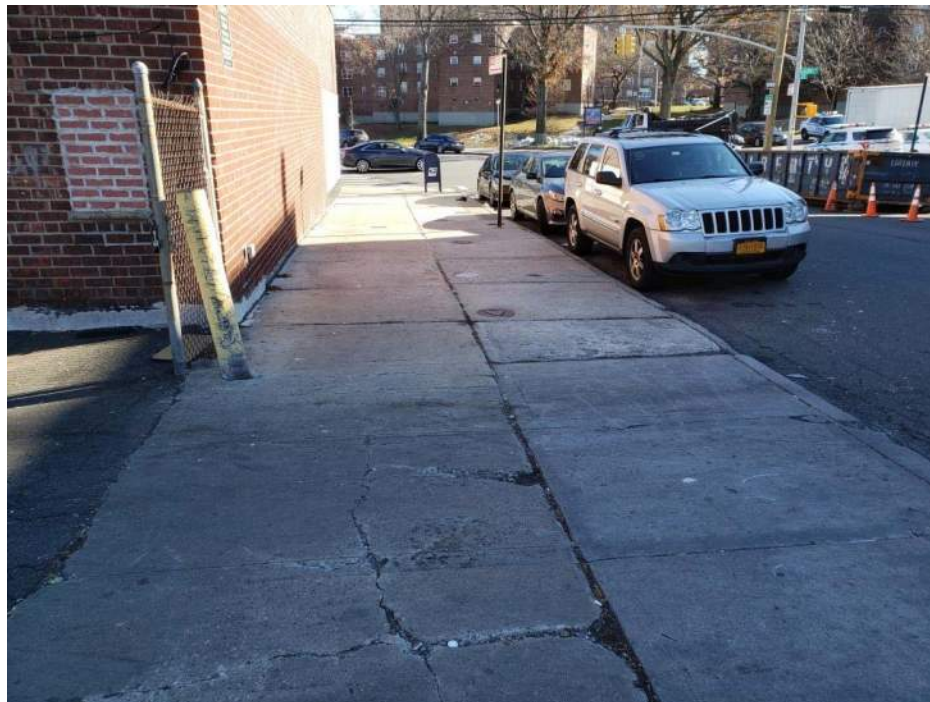
**Photograph 4:** East 230<sup>th</sup> Street sidewalk adjacent to the south end of the Site building looking east. Monitoring wells installed by others visible. Police station (not shown) is located to the right across East 230<sup>th</sup> Street.

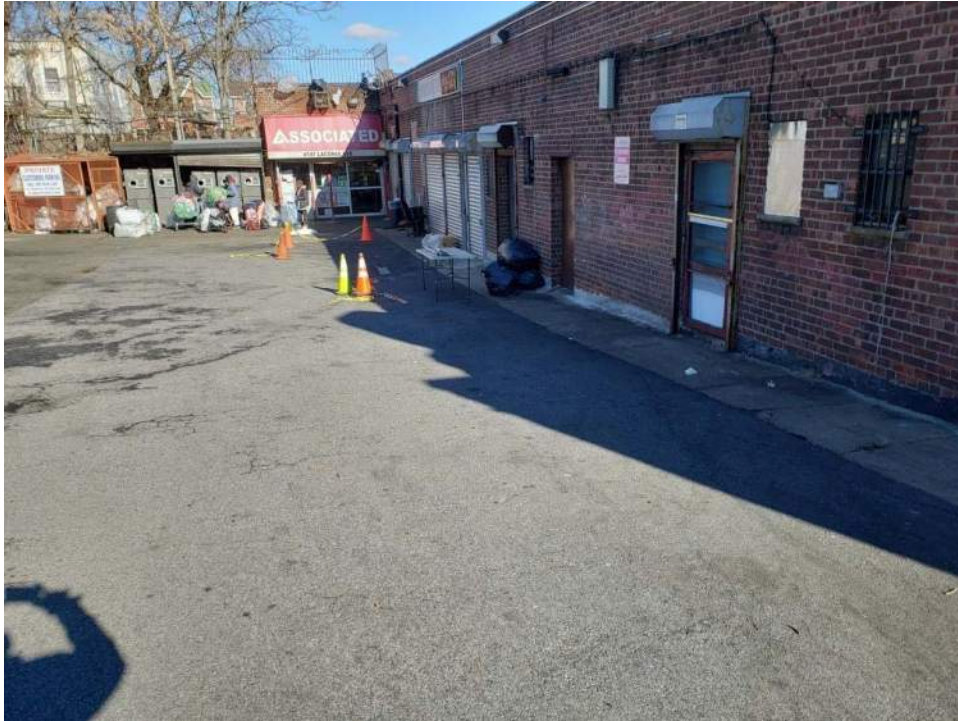
**Photograph 5:** Rear of the Site building. Safety cones mark the location of Soil Boring B2, which was placed adjacent to a storm grate.
